Arrow Air Inc.
Douglas DC-8-63 N950JW
Gander International Airport, Newfoundland

12 December 1985

Report No. 85-H50902

Dissenting Opinion

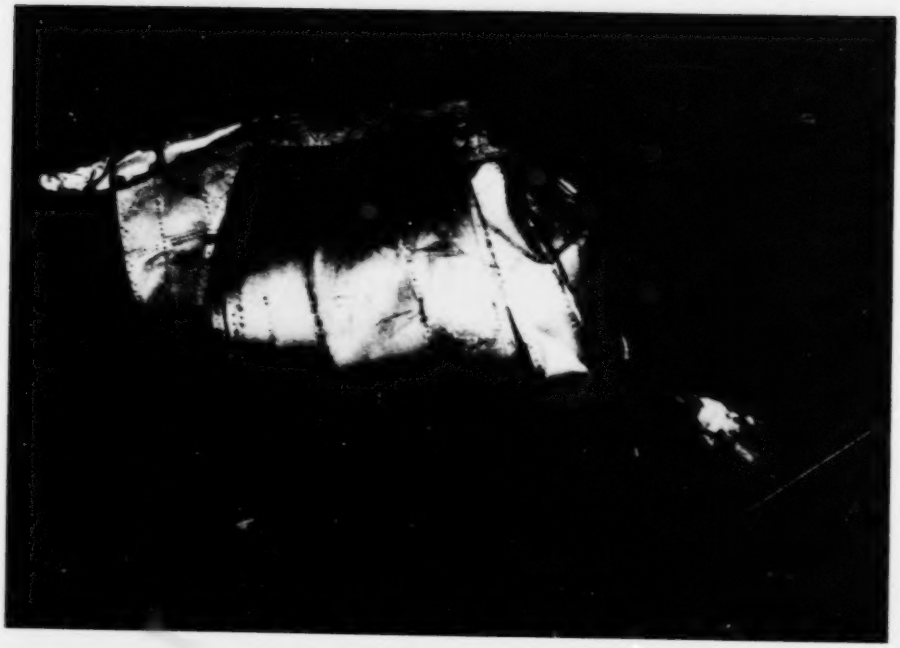
Figure DO1. Refueller's view of DC-8 leading edge

Two refuellers who could not fail to see the leading edge while connecting the fuel hose to the refuelling panels (see Figure DO1.) testified that they saw no ice. Had de-icing been necessary, it could have been provided on a fee-for-service basis. None of the four ground handlers who would have done the work noticed any ice. Earlier that morning, one of these workers recommended de-icing to the captain of an aircraft that had been at the airport for some time. This witness stated that the Arrow Air DC-8 did not need de-icing because there wasn't any ice on it.

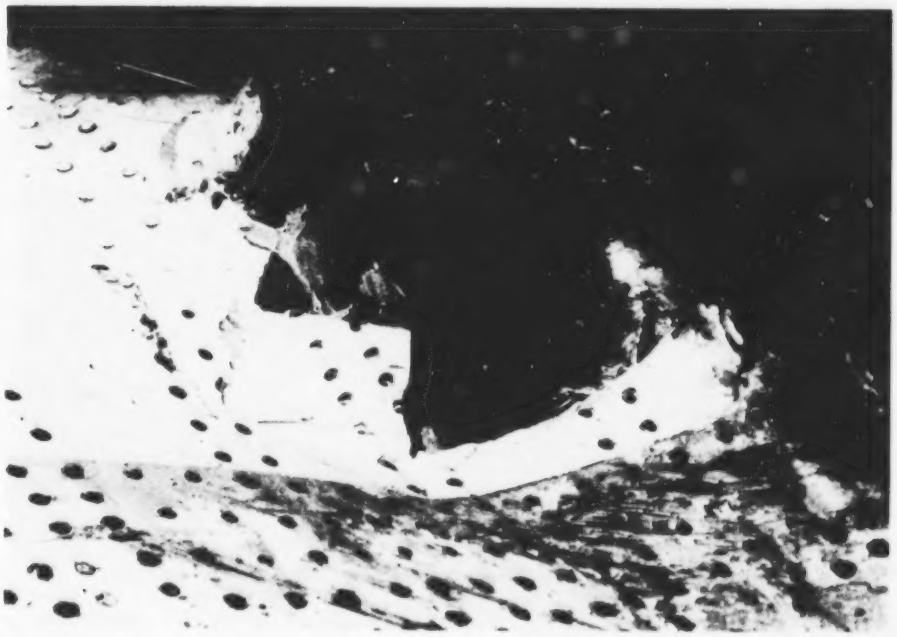
Figure DO10. Explosively punched hole in fuselage panel

An explosive expert acting as a consultant for the insurer examined some of the wreckage in the hangar at Gander. He believed he found evidence of an in-flight explosion. This evidence included a roughly circular hole some 11 inches in diameter in a fuselage sidewall. The hole, located just above the floor line in the passenger cabin, seemed to be punched out explosively. The fuselage section showed no damage other than the outward pucker around the hole (Figure DO10.). The partial window frame above the hole seems to be distorted outward as if from an internal blast.

The consultant believed that the hole could not have been formed in the panel after it had separated without other damage to the interior surface. But, an explosion in the passenger cabin while the sidewall was still attached to the floor may well have produced such damage. As would be expected in view of the extensive weathering of the debris, forensic examination found no evidence of explosive residue.

The majority attributes the hole to damage occurring during impact. We believe that such a hole could not have been punched in an unattached section without further damage and without indication of what might have caused it. Accordingly, we hold the consultant's hypothesis credible.

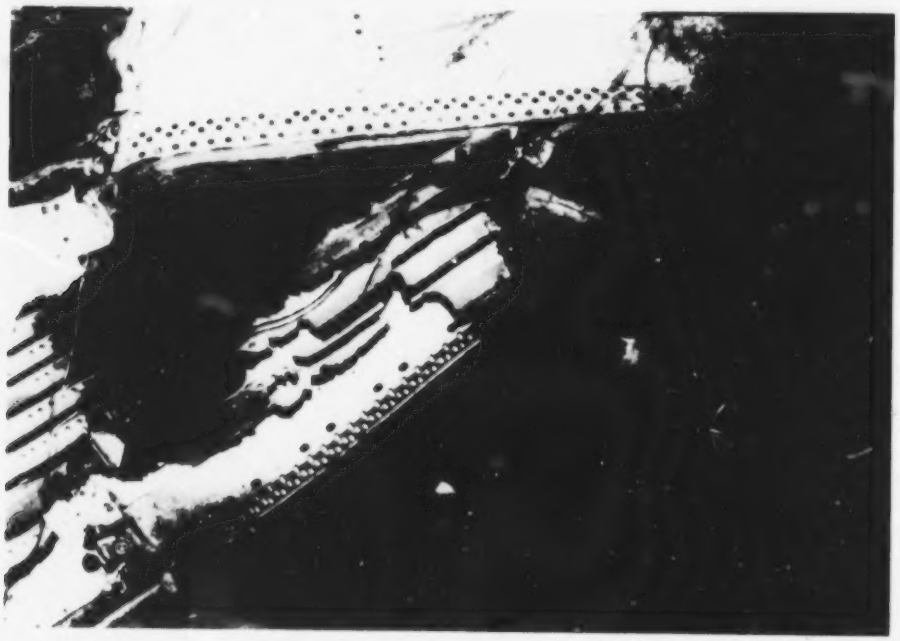
Our own examination of photographs of the wreckage found more evidence of possible explosions. Figure DO11. shows a substantial explosively ripped hole apparently on the underside of the aircraft. Figure DO12. shows an interior view. We could not establish the location on the aircraft, but the wide extent of battered and crushed ribs might be supposed to be the result of impact by material blown about by an explosion. Additional detail shown in Figure DO13. shows chips removed with no apparent local deformation. Such damage suggests high fracture rates typical of explosions.

A host of complex control breakdowns could ensue if the kind of battering illustrated in Figure DO12. were to occur in the ceiling of a forward baggage compartment where cables pass on way to the engines and flight controls. Such common cause failures could account for seemingly improbable simultaneous runaway flaps, in-flight deployment of thrust reversers, along with inability to raise the landing gear.
